# CONSTRUCTION INDUSTRY INCIDENT ALERT

### **Open Hole - Form Work**

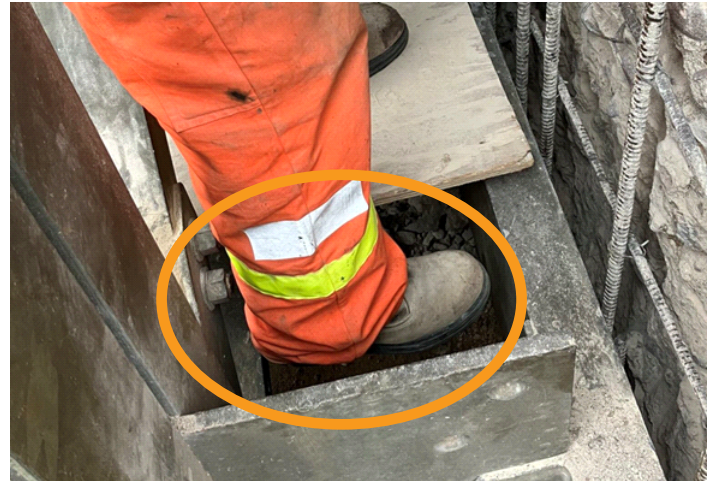
Employees were stripping form work approximately 2 feet off the ground and the boards were placed across steel frames to allow workers to have better footing.

This resulted in an opening approximately 10 inches long and 6 inches wide.

An employee stepped into this area, causing them to fall against a steel beam, resulting in a painful injury.

- Increase inspections to include areas where there is a potential for openings.
- Immediately cover openings, if found.
- Secure boards so they cannot be inadvertently moved while working.
- Develop and implement a procedure to ensure that steel frames are fully covered.
- Be aware of surroundings.

Ensure all walkways, floors, and work platforms are regularly inspected and that trip, slip and fall hazards are addressed immediately.
