# CONSTRUCTION INDUSTRY INCIDENT ALERT

### **Near Miss - Dropped Object**

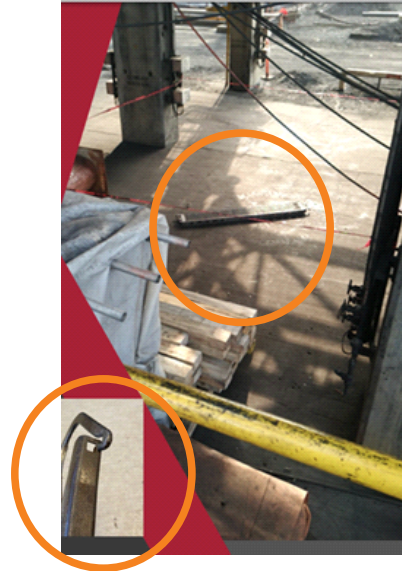
While dismantling a scaffold, workers were lowering a 2m scaffold plank that was attached to a rope with a hook.

While being lowered, the scaffold deck dislodged from the hook (which was damaged and did not close properly) falling, hitting some stairs and dropping approximately 36 feet.

When the deck released from the hook it deflected off a number of things on the way down and ended up approximately 10 feet outside the control zone.

- Inspect all lifting/tethering equipment prior to use and ensure that it is in proper working order.
- Review barricades and signage procedures to ensure that when lowering/lifting materials, no workers are within the control zone.
- Ensure control zones are adequately evaluated and are large enough to consider deflection of dropped objects.
- Review lifting procedures to ensure inspection of equipment is included. Confirm a process to ensure equipment failing an inspection is tagged and removed from service.

Ensure all materials and equipment that will be used to perform a lift is inspected prior to use.
