# CONSTRUCTION INDUSTRY INCIDENT ALERT

### Shoring Post Failure

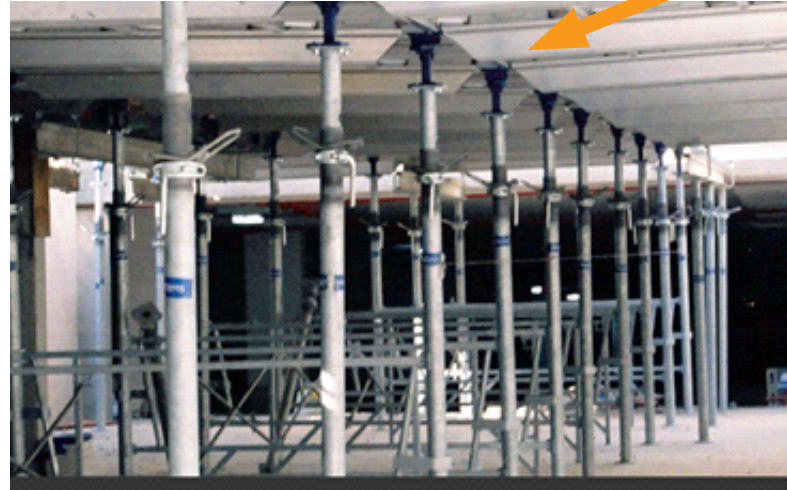
While conducting an inspection of a reshore post in an ill lit parking garage, workers noticed that some posts were loose.

Both surfaces (floor and ceiling) were sloped. One worker was checking and retightening the posts when a post behind the worker fell and grazed their shoulder, causing the worker to lose their balance. The worker fell to the floor and landed on their back.

- Ensure tools and equipment are capable of performing the identified task.
- Developed a procedure for shoring on sloped surfaces.
- Install more lighting in areas.
- Increase inspections of area for loose posts.
- Pay attention to surroundings and any loose posts.

When selecting tools and equipment, ensure they are going to be used in the manner in which they were designed.
