# CONSTRUCTION INDUSTRY INCIDENT ALERT

### **Near Miss - Exposure to Hazardous Substance**

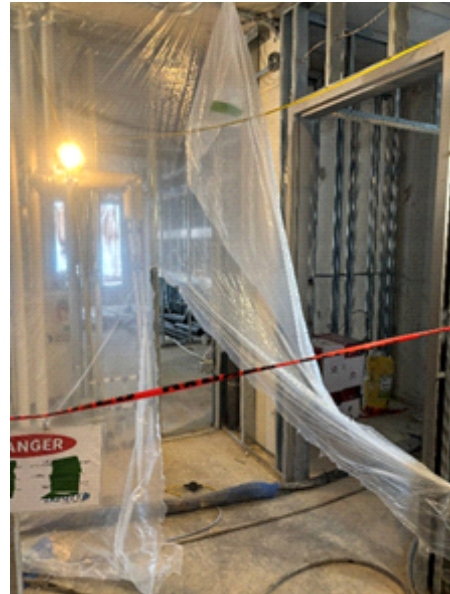
Upon receipt of complaint, there was an investigation and it was identified that a poly work enclosure had been set up at the entrance to the work area but 2 full steel stud side walls were left open (unsealed). This allowed substances to free float to other areas of the building and allow workers to walk through a work area.

- Ensure documented coordination of work meetings take place with all contractors on a regular basis.
- Inspect enclosure control zones prior to approving work to proceed and on a regular basis thereafter, to ensure it is being maintained.
- Ensure all trades/workers/contractors on a project understand the hazard and the controls that should be in place while working adjacent to one another.
- Ensure that workers report any issues/concerns to their supervisor.

**Ensure work enclosures fully encapsulate the hazardous work and all workers in the area are made aware of the hazards.**
