# CONSTRUCTION INDUSTRY INCIDENT ALERT

### Slip and Fall - Defective PPE

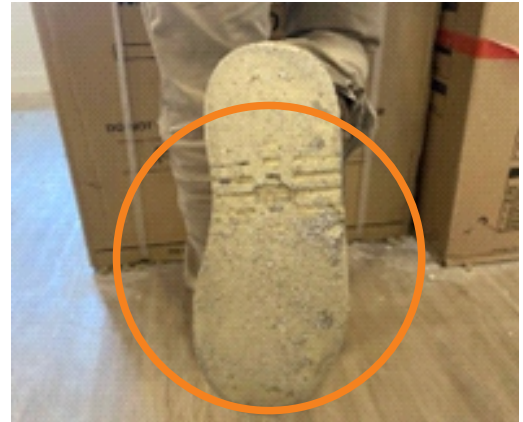
A worker accessed a patio on the 6th floor, while it was raining.

Their foot slipped and the trailing foot hooked on the threshold.

The worker fell towards the patio railing which caused a glass panel to break and fall to the ground below. The tread on the worker's safety boots was very worn down.

- Regularly inspect footwear. Ensure that there is sufficient tread to prevent slipping.
- Ensure PPE is suitable for the job and the current environmental conditions.
- Remind workers to not rush when completing work.
- Be aware of potential of dropped objects.
- Use caution when working in wet environments.

Ensure safety footwear is regularly inspected, in good condition and appropriate for the hazards.
