# CONSTRUCTION INDUSTRY INCIDENT ALERT

## DESCRIPTION OF EVENT

### Temporary Facilities

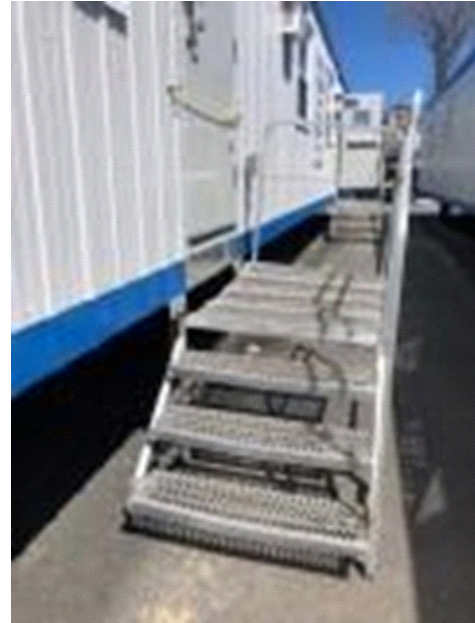
A worker was visiting a construction site and entered a temporary trailer through one door and began to exit through the second door when the worker realized that there were no stairs installed.

At the time of the incident there were no warning signs visible from inside the trailer and the door was not locked, blocked, or taped out of service.

- Ensure stairs affixed with handrails are located at all exits.
- Include temporary facilities stairways on inspection form.
- Ensure landings/stairs do not exit into potentially unsafe conditions such as roadways, parking lots etc. If so, ensure barriers are installed.
- Ensure level and good ground conditions to support temporary facilities and pedestrian traffic.
- Wind conditions may require anchoring of trailers and seacans.
- Securing secan doors open when in use to prevent doors blowing closed.

Ensure all exits and entrances are identified and maintained to ensure safe passage for workers.
