# CONSTRUCTION INDUSTRY INCIDENT ALERT

### **Near Miss - Dropped Object**

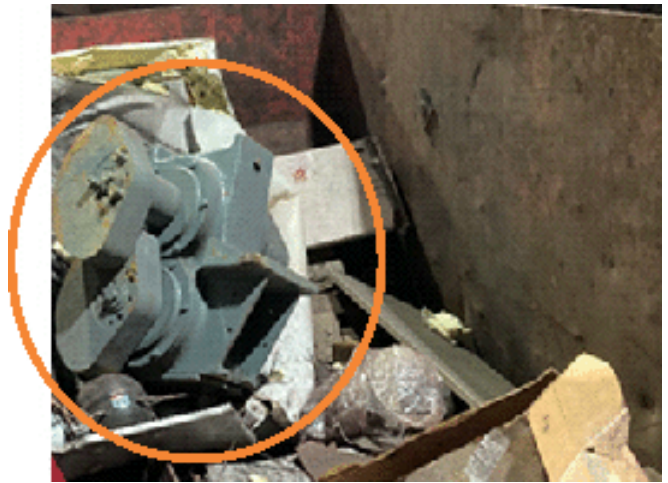
An unplanned activity, that included lowering a 1250lb agitator, resulted in the equipment dropping 15 feet into a garbage bin when the lifting point broke.

Due to the fact that the job was not part of the original work plan, a hazard assessment had not been conducted.

- Review the Hazard Assessment Procedure, specifically addressing changes in scope of work.
- Ensure all workers are aware of the requirement to revise or redo the hazard assessment when the job changes.
- Ensure proper rigging and lifting technique is used. Ensure that any critical information from the manufacturer is obtained and reviewed with workers.
- Inspect rigging and lifting equipment to ensure that it will be able to withstand the forces that are applied to it.

Ensure all materials and equipment is inspected prior to use and when the scope of work changes, hazards are reassessed.
